FIELD REPORT (10-13 MAY 2017)

CCAP SMART CENTRE SAFI/WATER FILTER DISTRIBUTION PROJECT-KARONGA

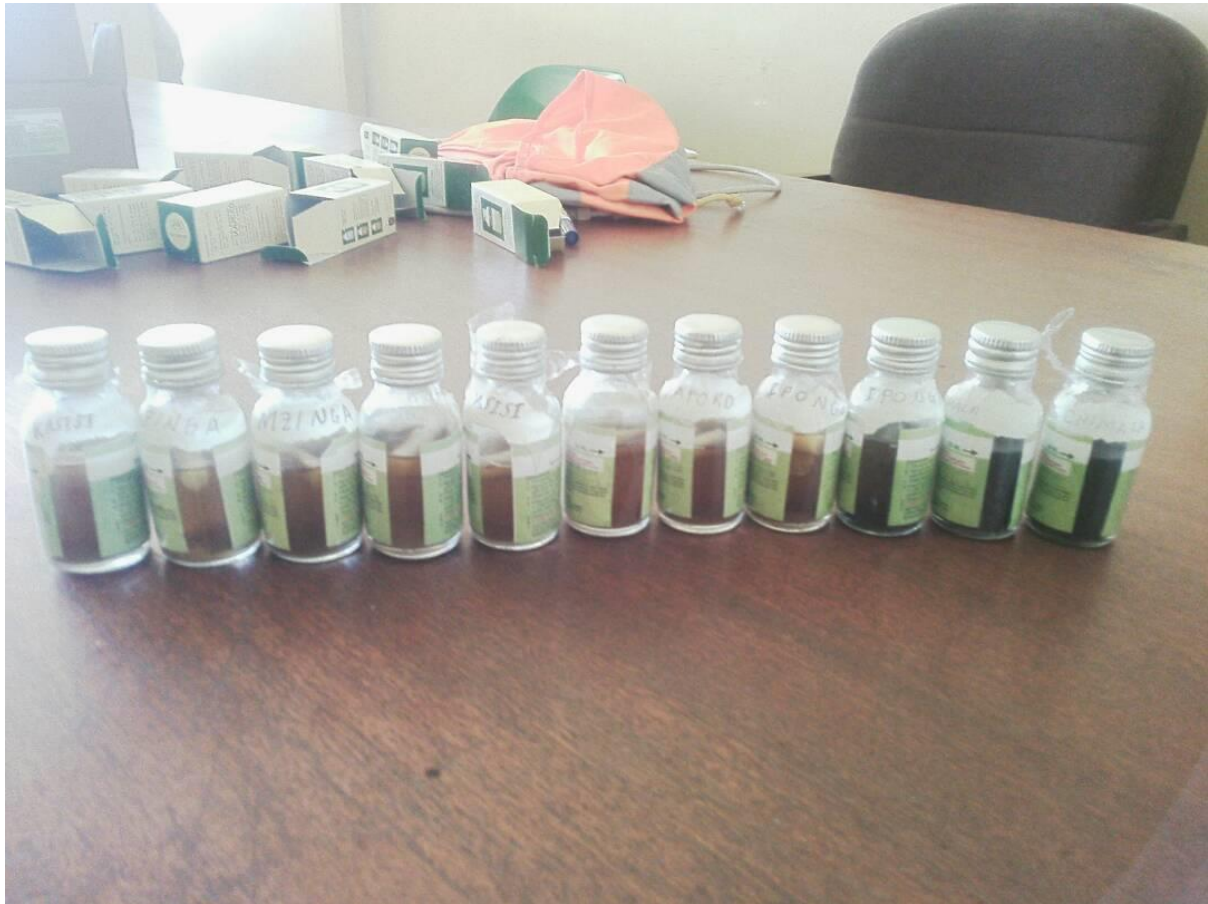
Water quality test results after 48 hours.

Table 2 show water quality test results after 48 hrs:

Camp Site	Water Source	Type of Samples Tested	Number of Samples per Site	Results	Interpretation
Kasisi	Borehole	Filtered Water	3	Negative	No change in colour, safe water for drinking
Mzinga	Borehole	Filtered Water	2	Negative	No change in colour, safe water for drinking
Chakwera	Borehole	Filtered Water	2	Negative	No change in colour, safe water for drinking
Iponga-Primary School	Borehole	Filtered Water	2	1 sample positive/ 1 sample Negative	Likely cause of the water sample that turned black was due handling of the filters during installation as the community had to be trained in the installation and basic cleaning techniques.
Iponga-Mwakawoko	Borehole	Filtered Water	2	1 sample positive/ 1 sample Negative	Likely cause of the water sample that turned black was due handling of the filters during installation as the community had to be trained in the installation and basic cleaning techniques.
Kaporo-Chimalawathu	Borehole	Filtered Water	2	Negative	No change in colour, safe water for drinking

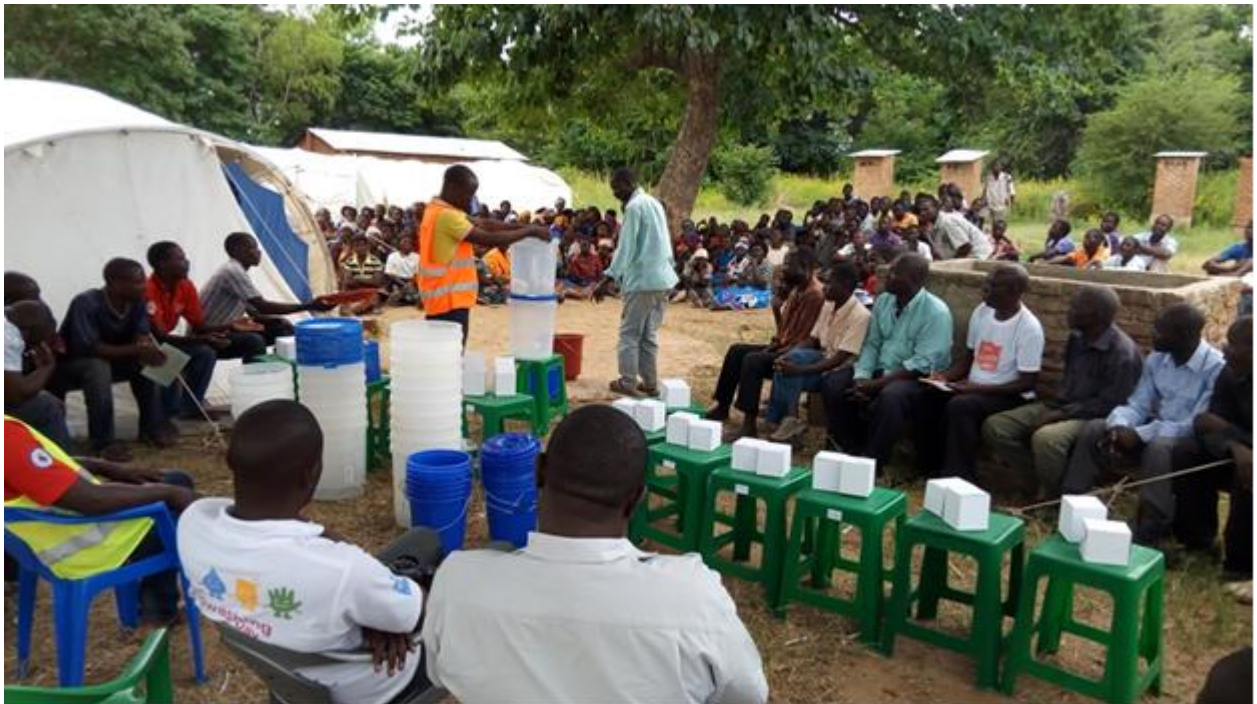
Aaron Msiska CCAP SMART Centre Demonstrating on Water Filter Assembling

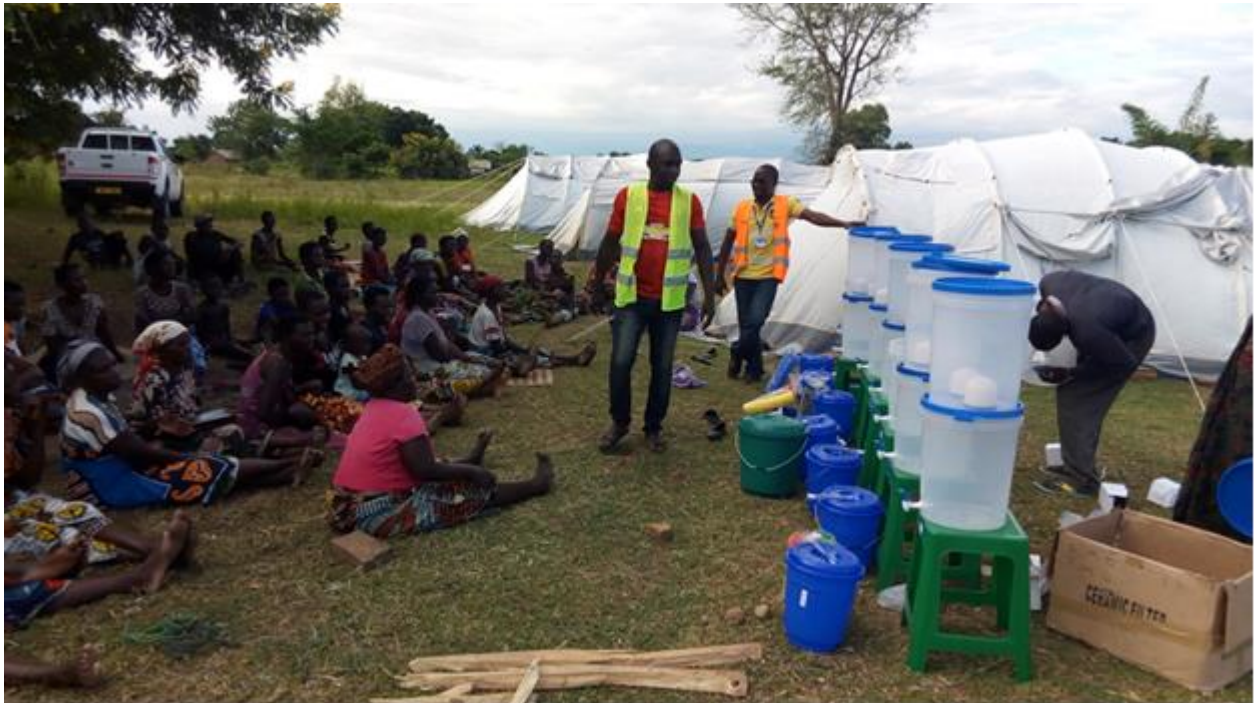
Waluza Muthari-SOLDEV Inspecting beneficiaries installing the Water filters
